Appling Park

Assessments:

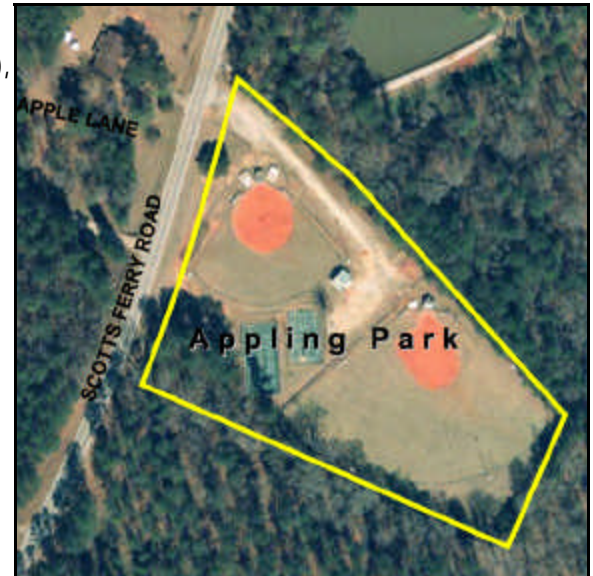
The Large Field is in good condition, with good turf coverage and a well-maintained infield. The dugouts are the arch-style that has been installed at other Columbia County ball fields. The lighting fixtures are mounted on metal poles. There is an older restroom/concessions building that is currently used for storage.

The Small Field has outfield fencing with the fencing fabric on the reverse side of the poles.

There is a newer restroom building - their current standard. No drinking fountain is installed on this building. There is no paved access to this building from the parking lot.

The basketball court is in good condition, the surface, goals and backboards are well maintained and in good condition. There is a bench installed nearby, but there is no lighting. There is no paved access from the parking lot to the basketball court.

- Add drinking fountain to restroom building
- Add concrete walks to tennis, and basketball courts and to the playground.
- Pave the entry drive and parking lot with asphalt; re-stripe to provide organized parking and designated handicapped parking spaces.
- Remove old restroom building, or renovate to provide storage for maintenance.
- Relocate playground so that it is not in the outfield of a ball field. Make sure equipment is inspected and a certified safety inspector observes installation. Update all equipment as necessary.
- Re-install the fencing on the small field so the fencing fabric faces the field of play.
- Add landscaping material near playground to provide shade.

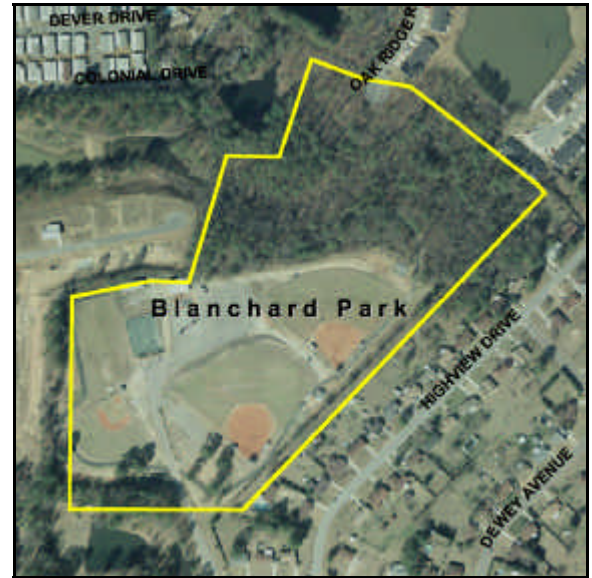
Blanchard Park

Field number one - is a 200' field with a turf infield. The field is in fair condition, as is the fencing.

Field number two - is a 330' field with a skinned infield. The outfield is used to play peeewe football (80-yards). The dugouts are in fair condition (but not up to par with other facilities in the system); the floor of the dugouts is infield mix and cinders. The fencing is in poor condition - many areas are bowed and rusted. The adjacent scorer's tower and restrooms are in disrepair and are no longer in use. There is some storage space in this building. There are no paved surfaces around this field.

One metal storage-type building on the property is used to house the football, baseball and cheerleader equipment supplied by the County. This building is in fair condition, and serves its function, although the structure is an eyesore in the park. The election commission uses a second metal building which functions for voting purposes. The exterior of this building is in good condition, although not aesthetically pleasing.

The tennis courts are in good condition, with good surfacing and netting. The tennis courts are lighted, and the lighting appears to be in good condition.

There is an older restroom building to the left of the entry that is in very poor condition. The building has been vandalized and fallen into disrepair over the years. This building is no longer in use.

The irrigation at many locations in the park is either broken or inoperable, according to County Park staff members.

- Park needs a new master plan for a complete rehabilitation.
- Remove older buildings currently not in use. (Including all scorer's towers, and two old restroom buildings)
- Construct new buildings to act as scorer's towers and restroom structures; add a concessions building.
- Re-route perimeter trail so that it will not interfere with games going on in the park.
- Remove metal storage buildings. Locate equipment storage in another County park facility.
- Replace irrigation throughout the park.
- Relocate basketball goal to a more remote parking area that will see less traffic from the entry drive.

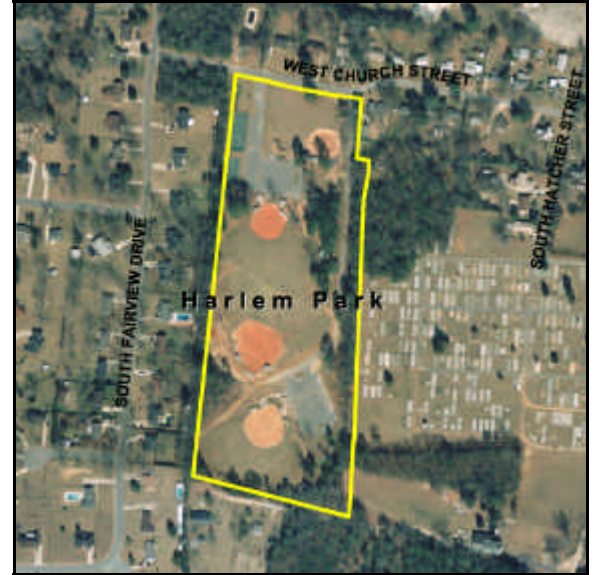
Entry Drive and parking lots are gravel or deteriorating asphalt. No parking lot is striped and there are no designated handicapped parking areas.

Field #1 - 200' field, skinned infield. The playing surface is in good condition, but the infield could use additional infield mix. Dugouts line the third base fence line due to the poor layout of the entry of the park. The first base line of this field's fencing is not more than 6 feet from the roadway entering the site. Since this field is programmed for use by T-ball and young girls' softball, both reported to be machine-pitch, the County has determined that a backstop is not necessary, according to County Park staff. Instead, a section of 8'-0" fencing is used as a backstop.

Field #2 - 200' field, skinned infield. The playing surface is in good condition, but could also use some additional infield mix. The dugouts have dirt floors and are constructed of wood and fencing with metal roofing. There is no paved access from the dugout to the bleacher pads. There are two sets of ten-row bleachers situated on concrete pads that connect to sidewalk leading to the parking lot.

Field #3 - 300' field, skinned infield. The fencing on this field was recently replaced in the outfield and along both foul lines to the dugouts. The remainder of the fencing is in good condition. The playing surface is in good condition, as is the infield. The dugouts are constructed of wood and fencing and feature metal roofs. There is no paved access to the dugouts from the parking lot.

The tennis court is in good condition and is lit with fixtures mounted on wooden poles.

The basketball court is in good condition and features arch-style concrete poles. The surface and equipment are in good condition. There is no paved access from the parking lot to the basketball court.

- Pave access to newer playground from parking lot.
- Add scoreboards to all fields - Coca-Cola usually will provide the scoreboards, but the County may need to install the wiring and pay for controllers and install scorer's stands.
- Replace all dugouts to match newest field style w/ arch top.
- Re-align entry drive to allow maximum spacing between the road surface and the fencing for Field #1. Re-grade and re-fence this field to provide for dugouts on both baselines, and install a backstop. Upgrading these items, while shortening the field slightly, will allow programming for league play.
- Pave access to the tennis court, basketball court, restrooms and baseball fields.
- Add landscaping to entry.

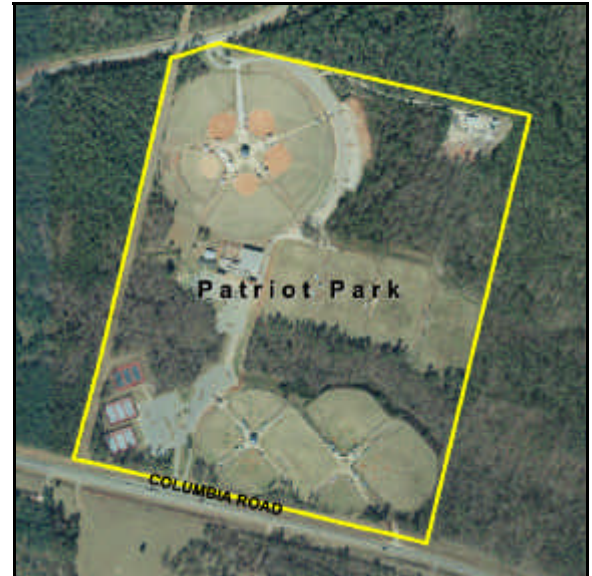
The entry signage is adequate, and the center median of the divided entry is nicely landscaped. The entry vehicular access is confusing for first-time visitors, with little signage to direct traffic to the proper parking locations for each activity. At the end of the divided entry median lies a war memorial. This memorial is in an unsafe location, and is accessible only by walking into the direct path of vehicular traffic or standing between cars parked in adjacent parking spaces.

The tennis complex lies to the west of the entry, and consists of nine tennis courts broken into three pods of three each. All of the courts are lighted and are in excellent condition. One pod of tennis courts has a set of bleachers situated on grass with no paved access. A small picnic area with a grill is situated to the south of the tennis complex and also has no paved access. A composting demonstration project is adjacent to the picnic area. This project needs additional maintenance and signage explaining the process if this is to become a feature of the park. There are 96 parking spaces associated with this complex, more than adequate.

The parking lot adjacent to this complex is inadequate. Current parking standards for soccer, baseball, and softball fields call for 60 spaces per field, while football usually requires 200 or more parking spaces. If this formula were applied to the six-field complex, 420-560 parking spaces would be necessary. There are currently less than 100 spaces adjacent to this complex.

The remaining three baseball fields (Navy, Columbia, and Peach) are situated surrounding a newer concessions/restroom building. This building represents the new County standard and is in good condition. The stucco material used on the sides of the structure is starting to show some wear, with a few places where either balls or bats have dented or put holes in the surface. There appears to be a drainage problem with standing water at the access point to the men's restroom on the north side of the building.

The Navy field is at a lower elevation than the surrounding pavement, and home plate is sunken +/- 4'-0" using Concrete gravity-type retaining walls. This wall is failing along the third base line, with serious erosion at the top of the wall causing erosion around the blocks and a hole in the soil surrounding the wall. This area is a safety hazard and should be remedied. There is an ADA accessible route to the 1st base dugout, but no ADA accessible route to the 3rd base dugout, instead there is a concrete stairway with no handrails. The field surface and fencing at this field are in good condition. This field is lighted and features a dome-style backstop and a scoreboard.

The Peach Field is a 200' field with a turf infield. The field surface is in good condition. There are no paved walkways leading to the bleacher seating or dugouts. The dugouts have weeds that are encroaching through the fencing and cracks in the sidewalk. There are no scoreboards on this field. The fencing on this field is in good condition.

The "Green" field is situated farthest east of the gymnasium complex and the parking lots. This field features soccer goals that also serve as football goal posts. This field has four sets of five-row bleachers, both situated on concrete pads. There is sidewalk access leading to one set of bleachers, but none to the other. There is a low, wet spot between the two bleacher pads. A pair of aluminum team bleacher benches is set in the grass adjacent to the field of play. The field is in excellent condition, with only small bare spots in front of each goal. Large nets line the south end of the field, providing protec-

The "Yellow" field lies to the west of the "Green" field and features soccer goals without football goalposts. The field surface is in excellent condition. There is protective netting at the north and south end of the field to provide protection from balls kicked into the woods. This field has no scoreboard or scorer's stand. There are 4 sets of five-row bleachers, all situated on concrete pads; one pair of bleachers is connected to a concrete sidewalk. There are two trash receptacles at this field, but only one team bench. A low spot between the "Yellow" field and the "Navy" field appears to hold water, causing a muddy depression.

The "Orange", "Maroon", and "Yellow" fields have 320' outfields and skinned infields. All of these fields feature similar backstops, bleachers, and dugouts to the "Gray" field. The "Orange" field has some minor repairs that should be made: the fencing is buckled at the 1st base side, and the 3rd base bleacher pad has a drainage problem.

The "Purple" field in this complex is the championship youth fast pitch softball field. The outfield is 200' and the infield is turf, with skinned base paths. The field turf is in excellent condition; however, the transition from turn to infield has a 4-6" lip in some places, which is a trip hazard and could cause injury to players. The fencing is black vinyl-coated and is in excellent condition. The outfield fencing features a protective yellow cap, and the backstop is black nylon netting. Behind the backstop are four sets of 10-row bleachers that are raised above the field level of play. A series of ramps and stairways lead from the concrete plaza to the bleacher seating at this field. The ramps do not appear to comply with the ADA requirement for landings every 30 feet, but also appear to have a slope shallower than the required 1:12. A picnic area with four picnic tables is situated directly behind home plate. There is a fenced pitcher warm-up area at the first base line.

- Repair drainage problem at new restroom building on north side of building nearest to the Navy field in the six-field baseball complex. Pour new concrete for positive drainage.

- Repair failing retaining wall at the Navy Field.
- Remove weeds, trash from backstop areas of Navy and Columbia baseball fields.
- Add sidewalks to Peach Field.

- Repair soccer netting that is torn or cut.
- Raise low spots between soccer fields to eliminate muddy depressions.
- Add facility identification signage to disc golf course.

- Repair warped or bent fencing in five-field complex. (Orange field, most notably)
- Add access points to the five-field complex and parking area from the park headquarters building.

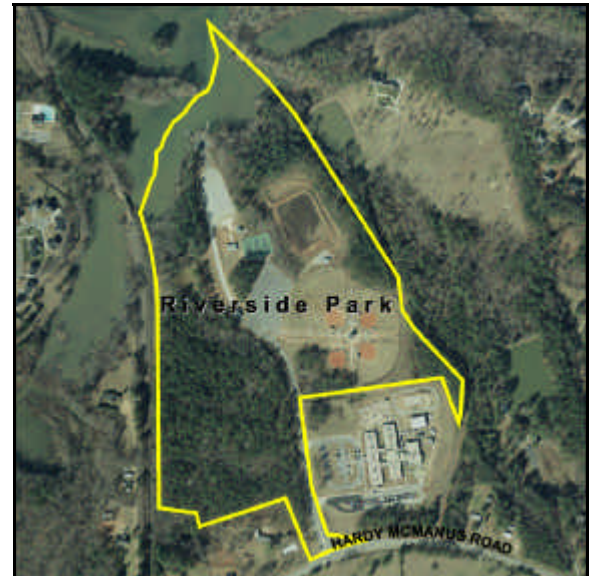
This area of the park features a large gravel parking lot with access to the Savannah River via a concrete boat ramp. There is a fishing dock with handicapped access, as well as a boat loading dock. These facilities are in good condition. There is a concrete pad that provides handicapped parking and access to these riverside facilities.

A picnic pavilion, a restroom building and a sand volleyball court are situated on the opposite end of the gravel parking lot. The buildings are in good condition, and the restroom structure has a water fountain mounted on the exterior. The sand volleyball court, on the other hand, is in need of repair. The sand is not being retained properly, causing sand to spill out onto the surrounding grass. A bank of three tennis courts is visible from this location, but accessed at a different elevation.

A maintenance compound is situated adjacent to the tennis courts. This compound consists of a storage shed and storage yard. The building is in fair condition, but could use minor reconditioning and cleaning.

The centrally located four-field complex has four ball fields, all with skinned infields, situated radially around a concessions/restroom/storage building. This structure is the newer County Standard, and is in excellent condition. This structure does not, however, provide an ADA accessible route to the second floor scorer's area. All of these fields feature playing surfaces and fencing that are in good condition. All of the fields except for the "Green" T-ball field are irrigated and lighted. All fields have two sets of 10-row bleachers on concrete pads.

This four-field complex also has a newer playground structure. This playground has no paved route to the entry, and may be located in an unsafe location - just outside of the first base line in the outfield of the green field.

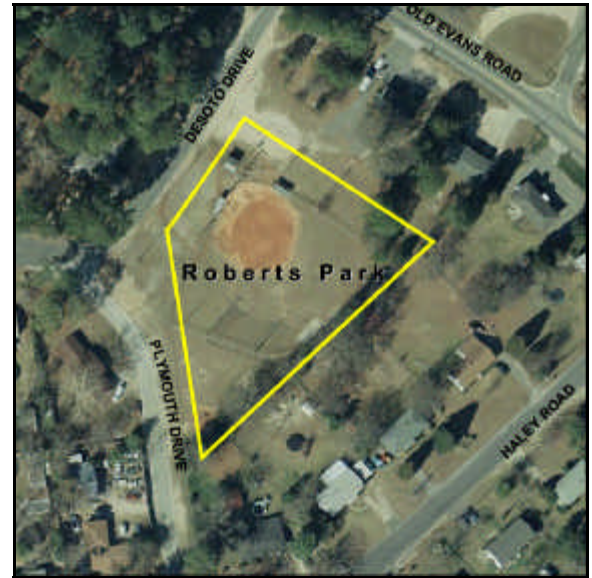
Roberts Park

This park is in very poor condition. The restroom building has been vandalized to the point that it is inoperable.

The ball field has a skinned infield and turf outfield. The field condition is poor. Lights on the field are operable, but appear to be in poor condition and may not be lighting to any sort of level that would support a league baseball or softball game. The lighting fixtures are mounted on wooden poles. There are no bleachers or water fountains at this facility.

The playground equipment is older, and much of it appears to be unsafe or in poor working condition. An adjacent half-court basketball pad is in fair condition but needs refurbishing.

- Remove the structures and fencing and all unsafe playground equipment.
- Install new playground.
- Install new backstop; create a "sandlot" type facility.
- Resurface basketball court and paint poles.
- Eliminate all parking, except for two handicap spaces.
- Pave walkways to the basketball court and playground from the parking lot.

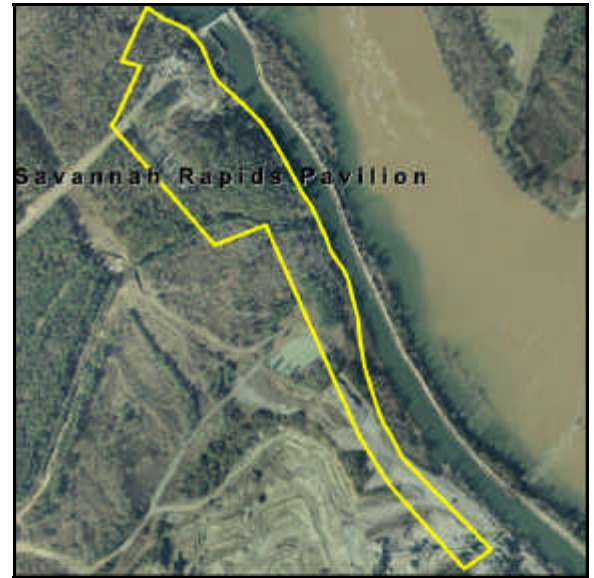
The pavilion building and immediate grounds are in good condition and have a master plan in place for enhancements to the immediate grounds and to the Savannah Rapids waterfront. The plan calls for parking, trail and pedestrian bridge enhancements, among others.

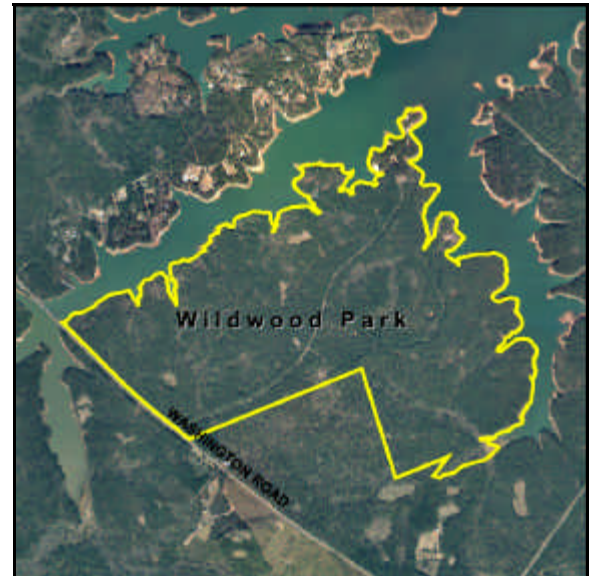
The park entry signage is relatively new and in very good condition. The signage is stone and wood construction, with some landscaping to accent. A long entry drive, mowed on both sides of the roadway, leads to a small gatehouse. Park personnel manage the gatehouse. A day-use fee is charged for entry to the park, as well as fees for the camping areas. To the east of the gatehouse, a gravel drive leads to a gravel parking lot that is used to store campers and recreational vehicles. The County charges a monthly fee for storage. The park property also contains two houses that provide residence for two park rangers and their families. These two rangers maintain and manage Wildwood Park. There is an abandoned archery range that is currently used for 3-D target shooting. This area is also available for rental. Hiking and biking trails cross the roadway as campers and beach-goers drive to their destination toward Strom Thurmond Lake.

The boat ramp at Area II is in good condition; however the gravel parking lot adjacent to this ramp receives heavy use on the weekends, causing some rutting and some loss of the gravel surfacing.

The beach area at this location is in poor condition, and is in need of additional beach material in the form of sand or turf grass.

The beach shelter at Area III is in poor condition. This shelter was created by removing the walls from a building that remained on site at the time when Columbia County took over the property from the Corps of Engineers.

The Area III beach area (adjacent to the westernmost boat launch) is in excellent condition, and seems to be a popular attraction. The associated boat launches do not appear to receive much use. These ramps are in good structural condition, but are overgrown with weeds as is the area surrounding the boat launch.

- Locate beach swimming area in a better location. Place pavilion w/ restrooms, volleyball and playground near the beach.
- Repair boat ramp at Area III and pave the adjacent parking lot.

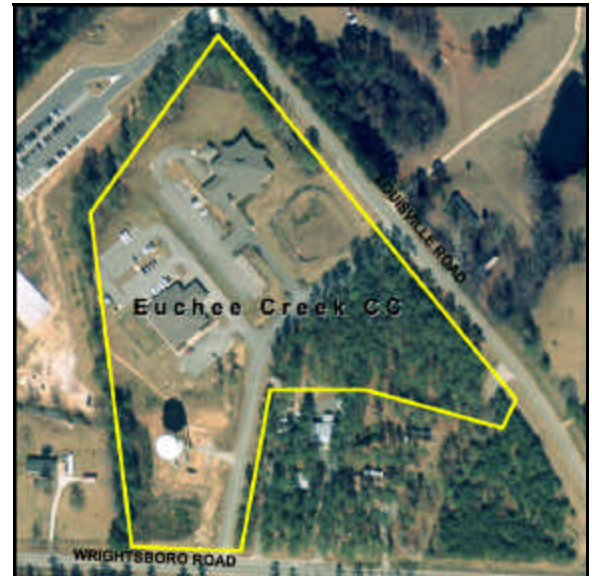
The Community Center Building acts primarily as a meal center, serving approximately 160 meals per day. Many of these meals are delivered, but some are served in the large activity/dining room. The activity/dining room has a fireplace that is reported to be inoperable, as well as several folding tables, chairs, and some entertainment equipment (a large screen television and a portable keyboard). This activity room is also available for rental by reservation through the County Parks Department, which causes some conflict at times.

The activity room overlooks a covered picnic shelter that was under construction at the time of the inspection visit. The Community Center also contains offices, a craft room with a kiln, a full kitchen with commercial-grade stainless steel appliances and fixtures, and storage rooms. A County Medical Center building shares the main structure.

- Provide paved connection to the library with an ADA accessible route.
- Repair the fireplace.
- Increase the size of this Community Center to provide additional programming opportunities.

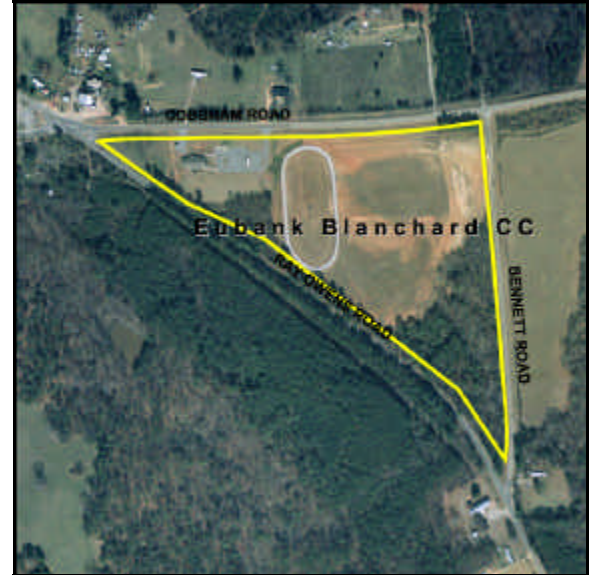
The Community Center building is in excellent condition. The main program room is very nice with hardwood floors, a large fireplace and wall-mounted speakers. The kitchen is fully equipped with commercial-grade stainless steel fixtures and appliances. The building is locked except on the occasions when it has been rented or programmed for use by the Community Centers Department. There is an ADA accessible route from the parking lot to the Community Center.

There is an asphalt walkway that leads from the parking lot to the cinder-surfaced walking track. This connection is in fair shape, but the curbing formed in the pathway causes runoff from the parking lot to erode the walking cinder walking track at the connection point. This creates ruts and loose cinders at this location, which may be a trip or slip hazard.

- Replace walking track access path with one that is safe, ADA compliant, and does not cause erosion problems.
- Pave the walking track.
- Provide more extensive playground options, with paved access to the playground.
- Provide picnic tables adjacent to Community Center.
- Purchase additional land around the Community Center property and add more recreation opportunities.
- Plant trees around walking track for shade.

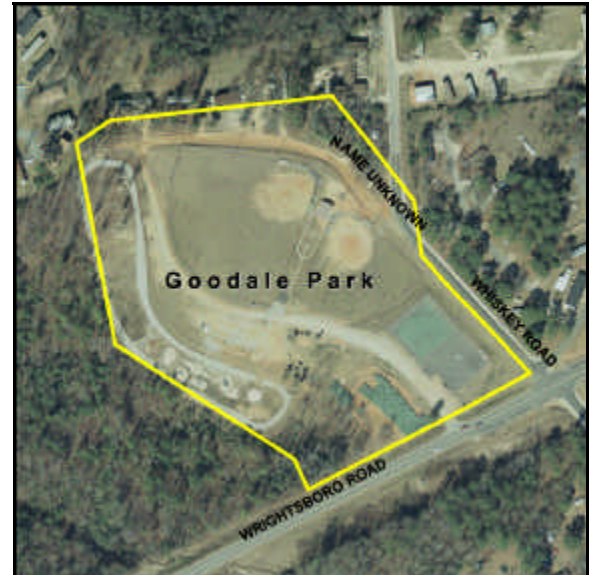
Both of the baseball/softball fields have playing surfaces that feature turf that is in good condition, but infields that are scattered with clumps of weeds. The lighting fixtures for these fields are set on wooden poles that are in fair condition. A concrete walkway leads from a small asphalt parking pad in the gravel parking lot for an ADA accessible route to a brick concessions/restroom structure between the fields. This building is in good condition externally, however, the design team was not able to inspect the interior at the time of the visit. The fields each have two sets of five-row bleachers for seating.

The gravel parking lot and gravel roadways within the park have areas of severe erosion and ruts, which could be a trip hazard to park patrons.

The tennis courts are in fair condition, with the asphalt playing surface starting to show age through cracks, although there are no weeds growing through them. The tennis courts have lights mounted on wood poles. A full-size basketball court with bleacher seating (five-row x 21 feet) is situated adjacent to the tennis area. This court is in fair condition, with few cracks in the asphalt playing surface, intact rims, and chain nets.

- Pave the parking lots.
- Provide paved ADA access points to all features of the park from the parking lot.
- Pave the 1/3 mile walking trail.
- Provide public restrooms.
- Replace infield mix on both fields.

- Upgrade lighting to County standards - if nighttime play is desired at this park.
- Replace unsafe playground equipment, upgrade play surfacing, provide ADA equipment and access.
- Replace signage to indicate that this park is a Columbia County Park.

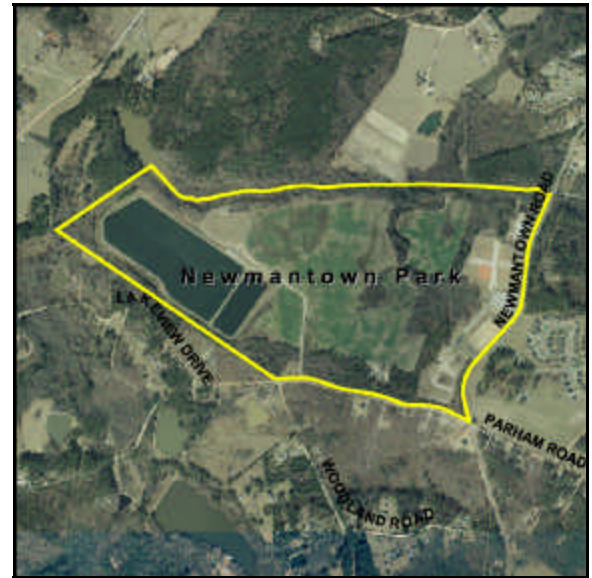
This park is a recent addition to the Grovetown City Park system. The first phase of construction is complete and includes four baseball/softball fields. All of the fields are lighted and irrigated, and feature new fencing and scoreboards.
